Service Facts

Desktop systems BIOS/UEFI Recovery required after Windows Update

Category:		DESKTOP
Version Number:		2.0
Version Date:		2025-06-20
Target Audience & Document Classification:		Fujitsu Public
Affected Product(s):	N/A	
Affected Operating System(s):	Windows	10

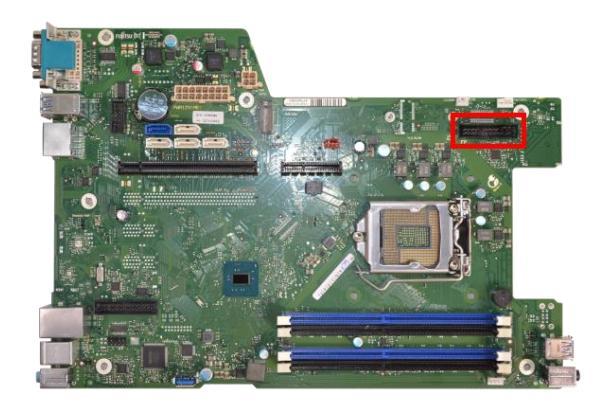
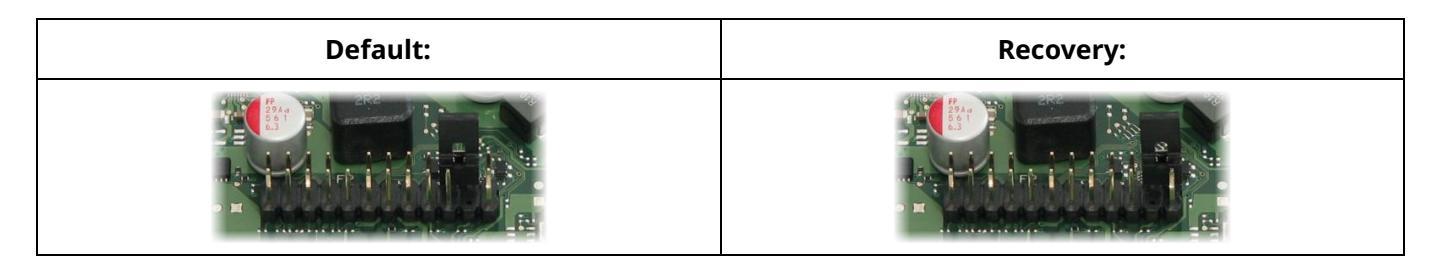
CELSIUS J550 / ESPRIMO D556 / ESPRIMO D756 / ESPRIMO D956 D3427-A1 / D3420-C1 / D3420-D1 / D3430-A1 / D3431-A1 / D3432-A1

FRONTPANEL location (sample image):

Jumper positions (sample images):

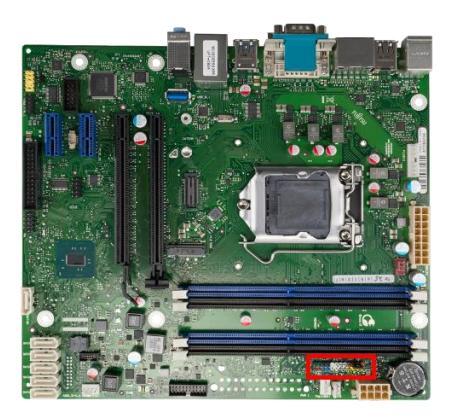
CELSIUS W550 D3417-A1 / D3417-A2

FRONTPANEL location (sample image):

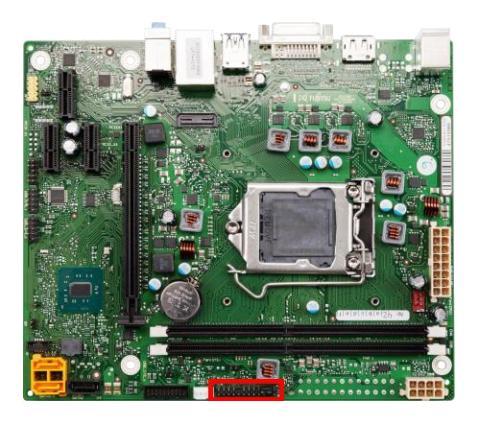
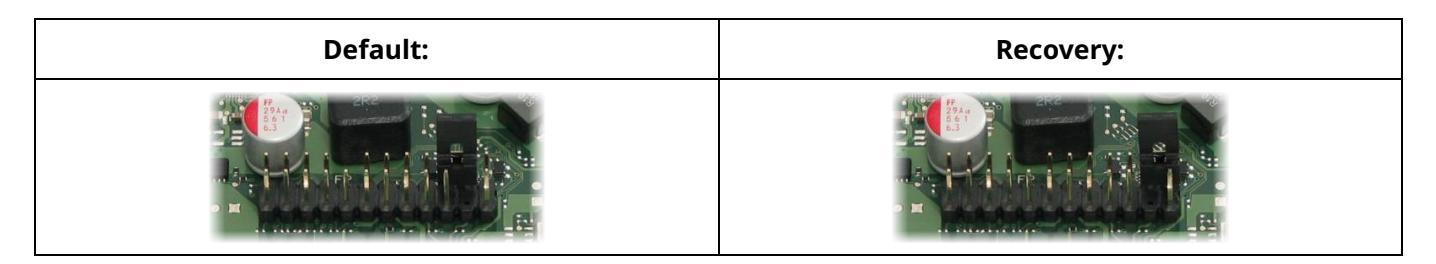
ESPRIMO P556 / ESPRIMO PH556 D3400-A1

FRONTPANEL location (sample image):

Jumper positions (sample images):

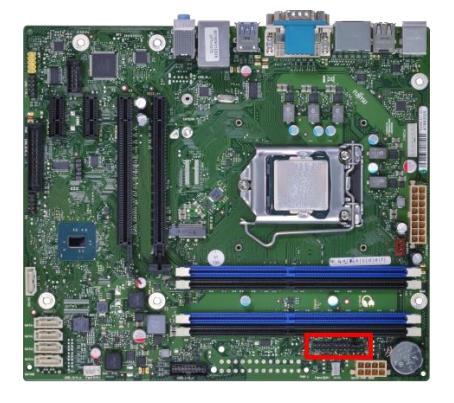
ESPRIMO P756 / ESPRIMO P956 D3401-A1 / D3402-A1

FRONTPANEL location (sample image):

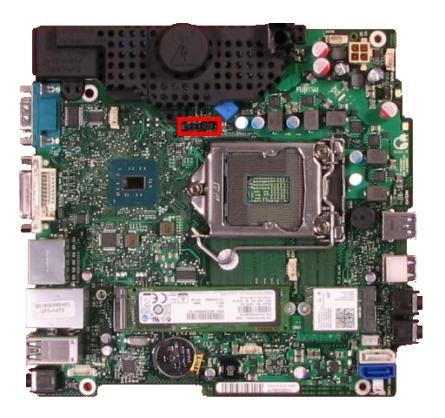
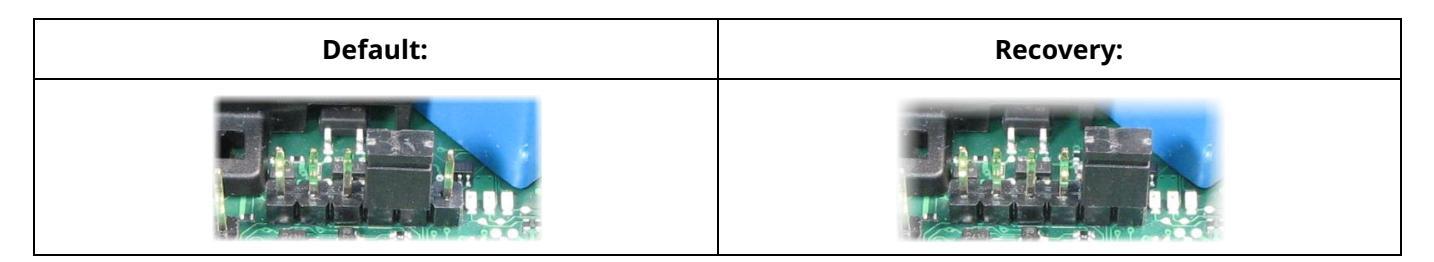
ESPRIMO Q556 / ESPRIMO Q956 D3403-A1 / D3403-B1 / D3413-A1

FRONTPANEL location (sample image):

Jumper positions (sample images):

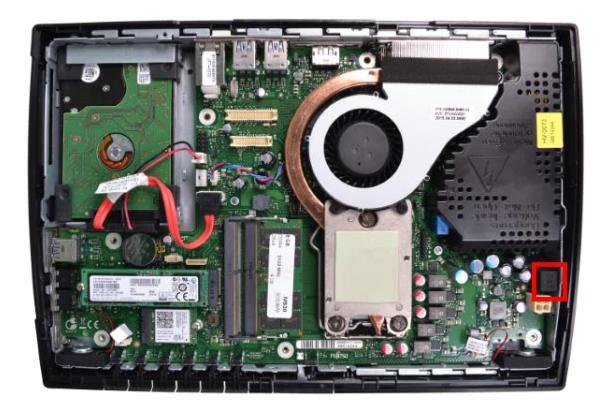
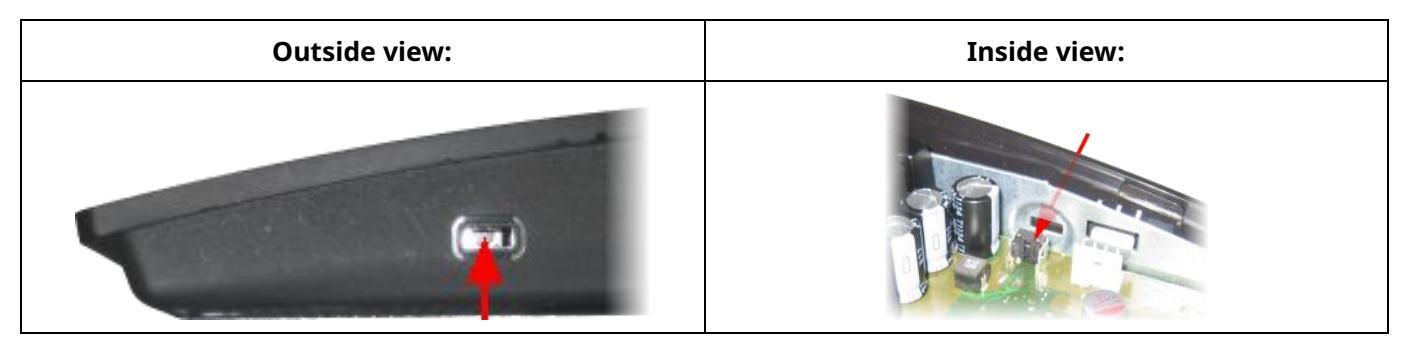
ESPRIMO X956 / ESPRIMO X956/T D3444-A1

Location of the Recovery Button:

In order to perform a BIOS/UEFI Recovery on this system you need to press the Recovery Button instead of setting a jumper.
